Appendix 3. Carrboro Stream Sites, March 2011

Bolin Creek sites are numbered from most upstream (Site 1) to most downstream (Site 4). Site 4 was moved from Estes Drive (at the town boundary) to Village Drive in Chapel Hill. Samples from Bolin Creek and Morgan Creek were collected on March 16, 2010; tributary sites were sampled on March 22, 2010.

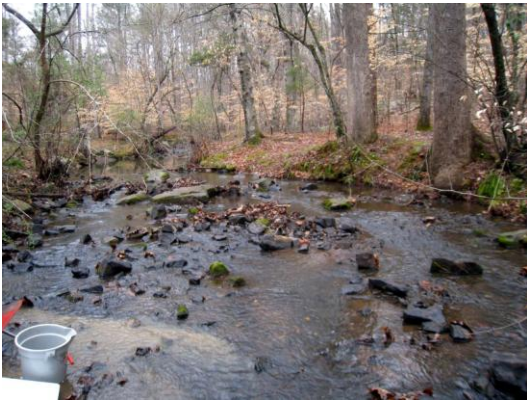
Bolin Creek Site 1, March 2011.

This part of Bolin Creek averaged about 4-5 meters wide, with a substrate mainly composed of gravel and rubble. Both the substrate composition and the width, however, were highly variable. There were no significant habitat problems in this section of Bolin Creek. There were abundant growths of filamentous algae at this site, especially along the edges of pools.

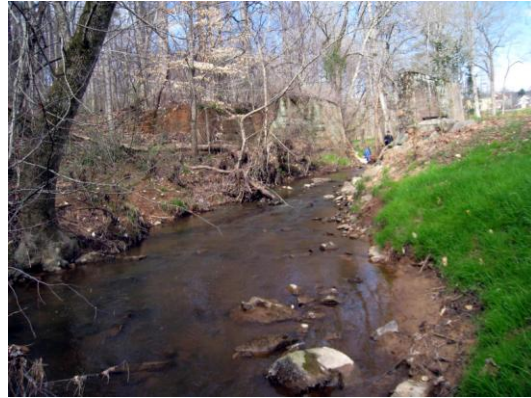
Bolin Creek Site 2, March 2010.

Bolin Creek 2. Site 2 is located downstream of the Winmore development at SR 1777. There is private residence on one side of the stream that lacks a buffer zone. Consequently, there is significant bank erosion on one side of the stream.

Relative to Site 1, there was an increase in the amount of sand and silt (Table 1). Habitat problems included fewer riffles, bank erosion, lack of a buffer on one side and a decrease in habitat diversity. The amount of filamentous algae increased relative to site #1, with floating mats observed in some parts of the stream.

A beaver dam was observed slightly upstream of this site.

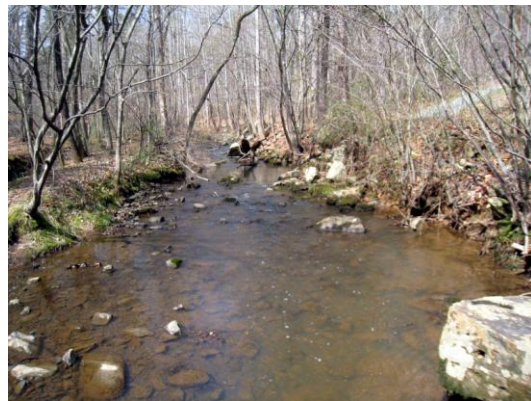
Bolin Creek Site 3, March 2010.

There are no significant habitat problems in this portion of the stream, although there were large amounts of brown algae and silt on all surfaces.

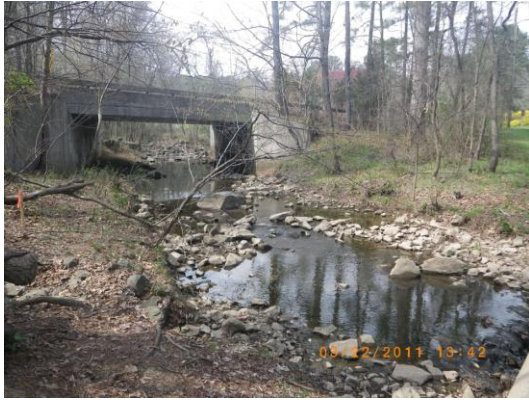
Bolin Creek Site 4, March 2011.

This portion of Bolin Creek is similar to the site on Estes Drive, having good rocky substrate. Attached filamentous algae was very abundant at the Village Drive site in March 2011.

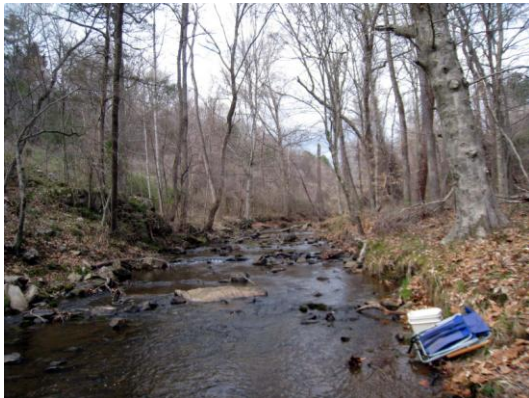
Morgan Creek, NC 54, March 2011.

This catchment has a largely rural character, with some minor impacts from nonpoint source runoff. Habitat quality, stream width and substrate composition are similar to Bolin Creek, but with less residential land use.

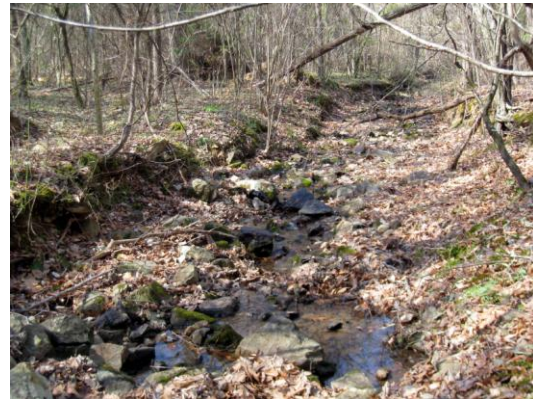
UT Bolin Creek, Seawell School Rd, March 2011.

UT Bolin Creek at Seawell School Rd. This very small UT was first sampled during a search for high quality streams in March 2009. The stream was completely dry in its upper reach, but groundwater inputs produced small areas of flowing water about 50 meters further downstream.

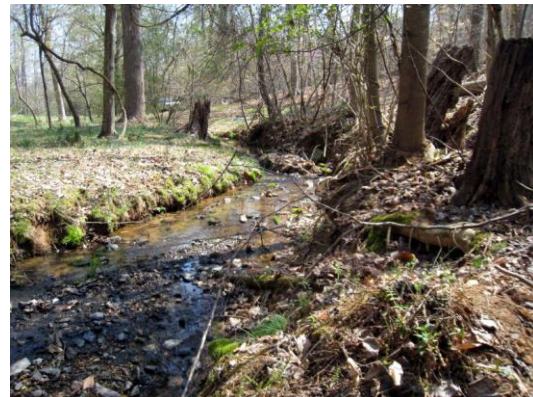
UT Bolin Creek, Hornehollow Rd, March 2011.

UT Bolin Creek at Horne Hollow. This small stream was suggested for sampling, as it appears to have more permanent flow than Bolin Creek. It runs through an older residential area with large lots.

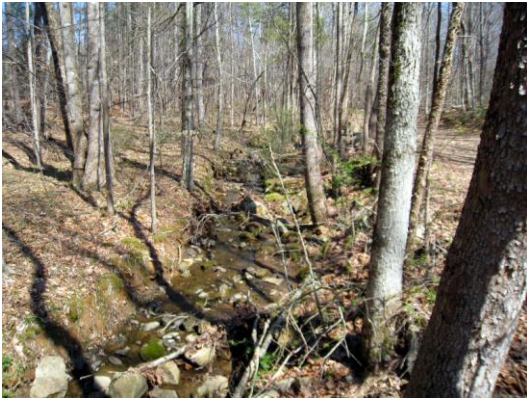
Jolly Branch, March 2011.

Jolly Branch near SR 1777 (just downstream of Bolin Creek 3). This site was accessed by walking about 100 meters downstream of SR 1777 (Homestead), crossing Bolin Creek, and going about 30 meters upstream on Jolly Branch. This small stream (1 meter wide) had good rocky habitat, but showed severe bank erosion in many places.

The surrounding area was largely forested, although there are residential areas further upstream. The aquatic life at Jolly Branch indicates that it may stop flowing (or go dry) during drought periods.
